## Somebody's Always Watching

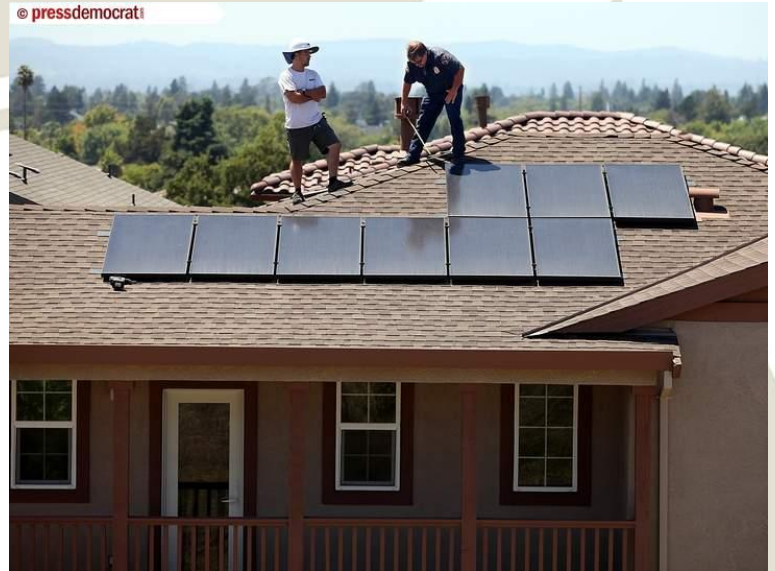
The picture shows a fire inspector in California inspecting for the required setback distance of roof mounted solar panels. The distance he is measuring is for the travel of firefighters conducting roof operations.

**The problem with the photo is that the state OSHA compliance office issued a citation to the department after viewing the article when it was ran in the local newspaper.**

The safety hazard identified was that there was no fall protection in place for this non-emergency operation. With the roof height being 24 feet off the ground, the inspectors department was given a \$2,700 fine.
